Client: 17120A Enclave at Broadmoor Glen

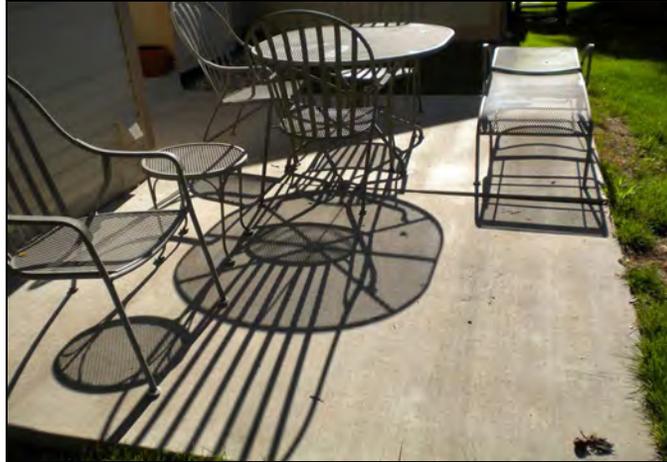
**Comp #:** 103 Concrete Patio - Repair (part)

Evaluation: Concrete patios are in overall good to fair condition with some signs of cracking and settlement. Recommend filling cracks to mitigate subsurface moisture, which will contribute to further deterioration. Allowance to repair and replace as needed.

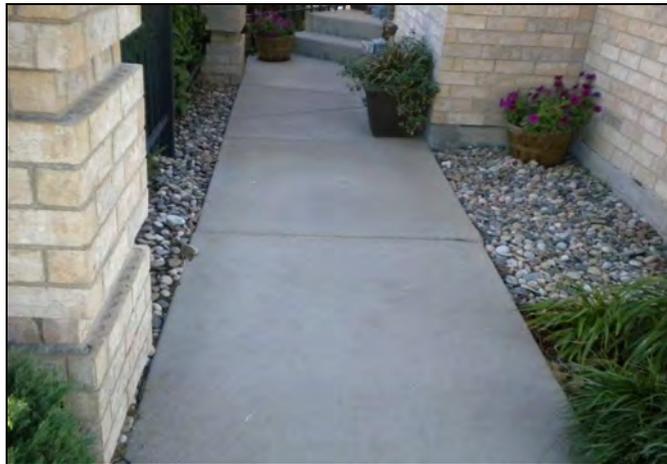
**Comp #:** 103 Concrete Walkway - Repair (part)

Evaluation: Walkways range from good to poor condition with signs of cracks, settlement and flaking on walks with a northern exposure. Recommend filling cracks and repairing any trip hazards immediately.

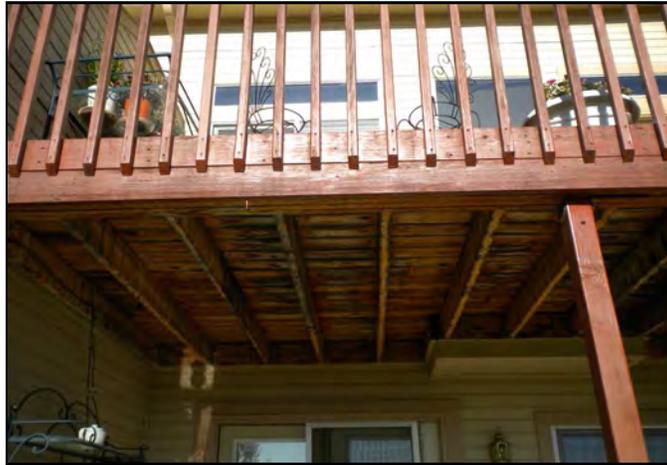
Comp #: 109 Wood Deck Phase 1 - Replace 25%

Evaluation: Decks range from fair to poor condition with signs of cracks and deterioration. Decks are made of 2x6 decking with 2x2 pickets, 2x4 rails and 2x6 caps. Currently approximately 6 decks have been refurbished by replacing the 2x8 joist with new material, and replacing the 2x6 decking and guardrail with a composite (TREX) type of product. As reported by the manager, cost for replacing decks (with composite) has been divided in half between HOA and owners, after which, owners will take full responsibility for maintaining decks. Funding is to replace remaining decks over a 10 year cycle, as cooperation with homeowners has slowed with the drop in the economy.

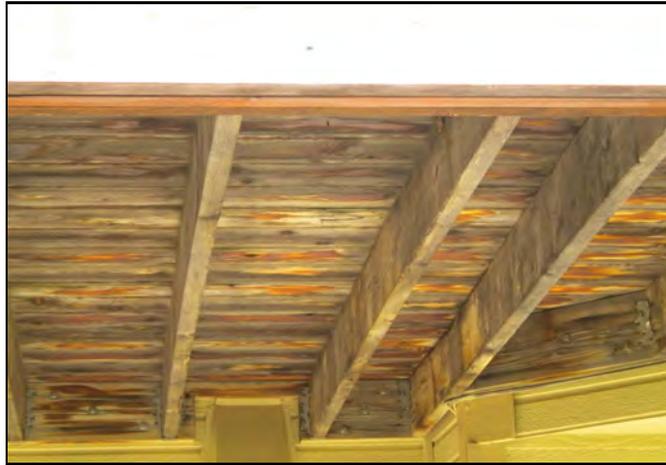
Comp #: 109 Wood Deck Phase 2 - Replace 25%

Evaluation: Decks range from fair to poor condition with signs of cracks and deterioration. Decks are made of 2x6 decking with 2x2 pickets, 2x4 rails and 2x6 caps. Currently approximately 6 decks have been refurbished by replacing the 2x8 joist with new material, and replacing the 2x6 decking and guardrail with a composite (TREX) type of product. As reported by the manager, cost for replacing decks (with composite) has been divided in half between HOA and owners, after which, owners will take full responsibility for maintaining decks. Funding is to replace remaining decks over a 10 year cycle, as cooperation with homeowners has slowed with the drop in the economy.

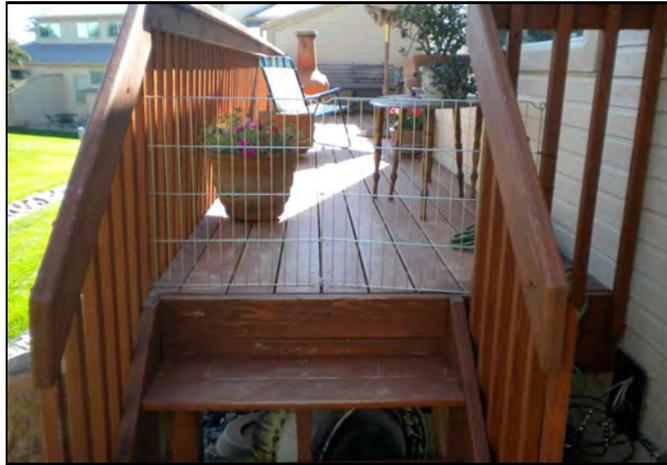
Comp #: 109 Wood Deck Phase 3 - Replace 25%

Evaluation: Decks range from fair to poor condition with signs of cracks and deterioration. Decks are made of 2x6 decking with 2x2 pickets, 2x4 rails and 2x6 caps. Currently approximately 6 decks have been refurbished by replacing the 2x8 joist with new material, and replacing the 2x6 decking and guardrail with a composite (TREX) type of product. As reported by the manager, cost for replacing decks (with composite) has been divided in half between HOA and owners, after which, owners will take full responsibility for maintaining decks. Funding is to replace remaining decks over a 10 year cycle, as cooperation with homeowners has slowed with the drop in the economy.

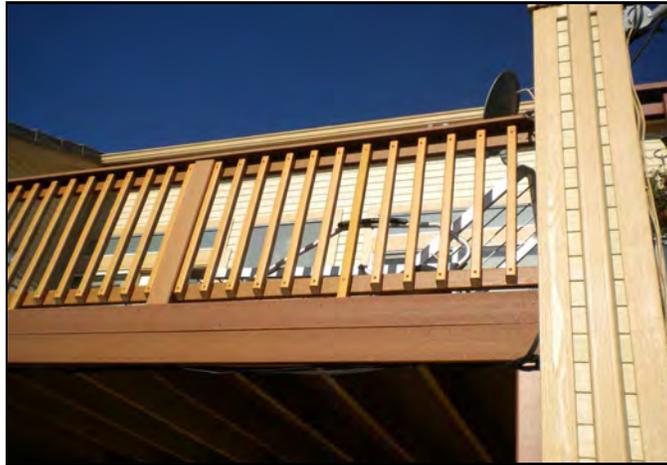
Comp #: 109 Wood Deck Phase 4 - Replace 25%

Evaluation: Decks range from fair to poor condition with signs of cracks and deterioration. Decks are made of 2x6 decking with 2x2 pickets, 2x4 rails and 2x6 caps. Currently approximately 6 decks have been refurbished by replacing the 2x8 joist with new material, and replacing the 2x6 decking and guardrail with a composite (TREX) type of product. As reported by the manager, cost for replacing decks (with composite) has been divided in half between HOA and owners, after which, owners will take full responsibility for maintaining decks. Funding is to replace remaining decks over a 10 year cycle, as cooperation with homeowners has slowed with the drop in the economy.

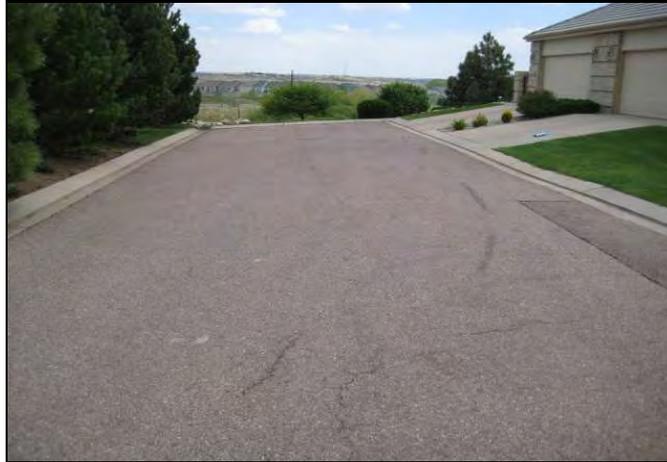
**Comp #:** 201 Asphalt - Resurface

Evaluation: Asphalt is reported to be the responsibility of the City of Colorado Springs as evidenced by their care for this section. This component is deleted from the Reserve Fund.

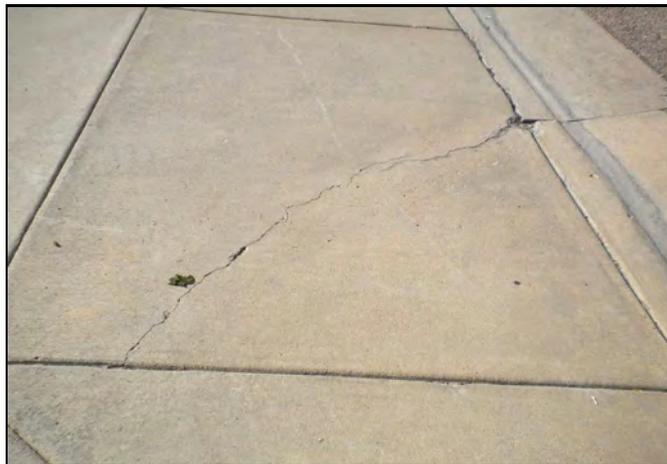
**Comp #:** 205 Concrete Driveway - Repair (part)

Evaluation: Concrete driveways range from new to poor condition with some signs of cracks and settlement and at least two needing immediate repairs. Recommend filling cracks and repairing trip hazards to prevent subsurface moisture penetration which will accelerate the useful life of this component.

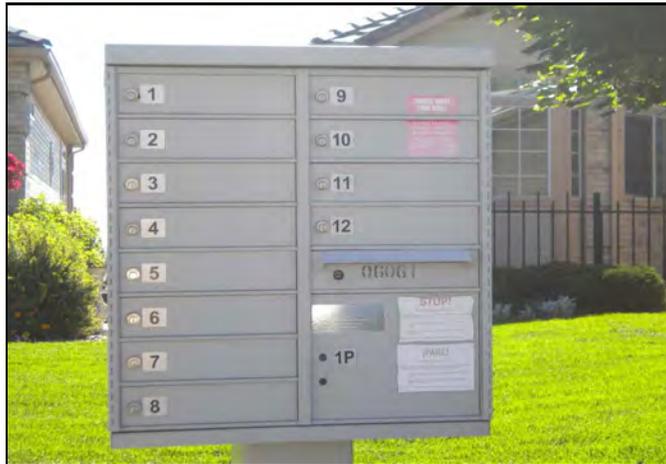
**Comp #: 403 Mailboxes - Replace**

Evaluation: Cluster box units appear to be the responsibility of the US Postal Service. As reported by Growth Management, a division of the Postal Service (719) 570-5415, numbers stenciled and painted on the boxes starting with the first two numbers of the last two digits of the zip code, followed by a 3 digit number for a total of 5 digits are designated as the responsibility of the postal service. Boxes marked with 4 digits are typically designated as HOA responsibility. This component is removed from the Reserve Fund.

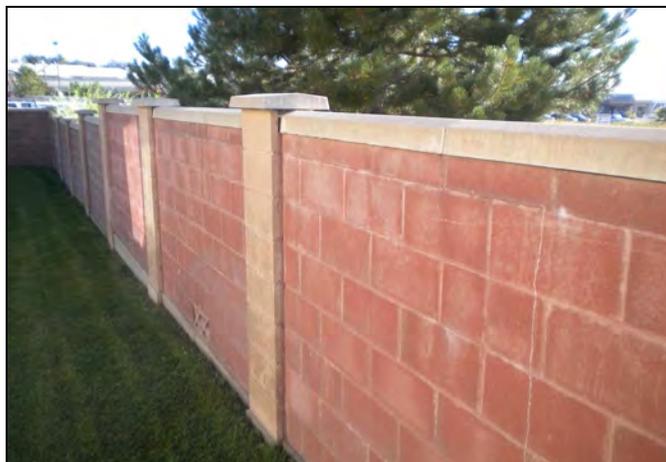
**Comp #: 501 Block Wall - Repair**

Evaluation: Colored cinder block wall and pilaster with concrete caps are in overall good condition. Funding anticipates repairs as needed with no anticipation for completely replacing entire wall at one time.

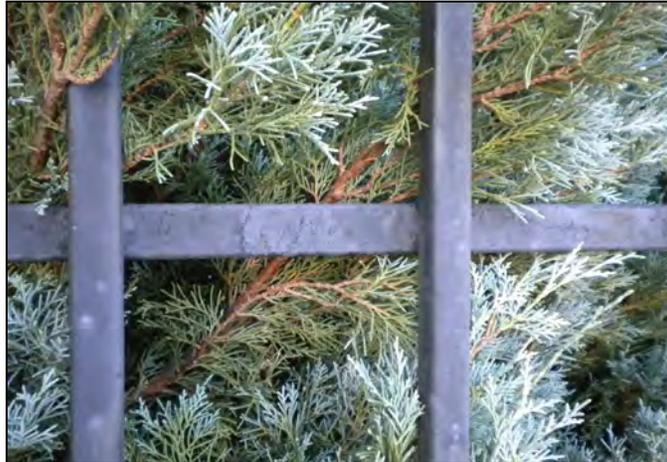
**Comp #:** 503 Metal Fence - Replace (part)

Evaluation: Fence is in good condition and intact with minimal signs of rust. Recommend removing vegetation that is in contact with metal as this will retain water and accelerate the useful life of this component. Regular repainting will maintain the appearance and prevent rusting. Funding is to replace sections as needed with no expectancy for complete replacement of entire fence at one time.

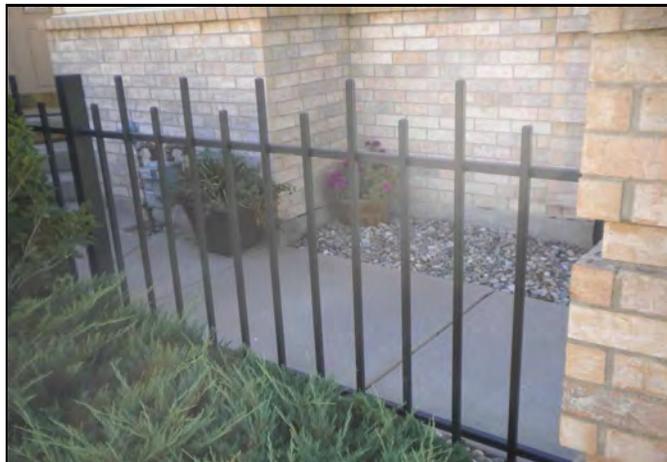
**Comp #:** 503 Unit Fence - Replace (part)

Evaluation: Metal fence and gates are in overall good condition with no significant signs of rust or damage. Recommend regular repainting to maintain appearance and prevent rusting. Funding is to replace sections of fence as needed with no expectancy for complete replacement of all fencing at one time.

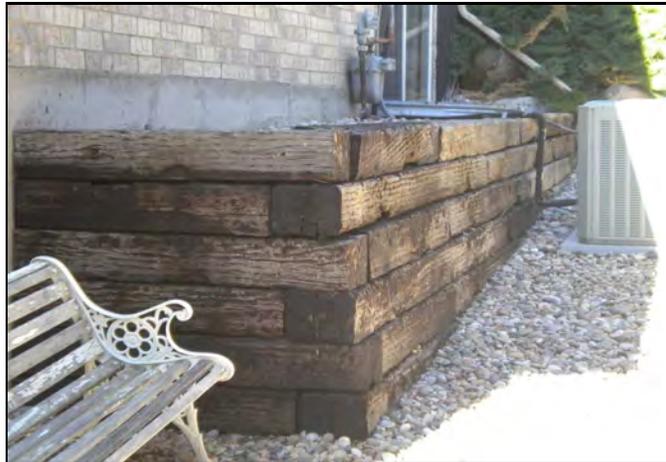
**Comp #: 512 Retaining Walls - Repair**

Evaluation: Retaining walls consist of railroad ties or rock/boulders. All walls appear intact with no significant signs of movement or leaning. Funding is to repair areas as needed.

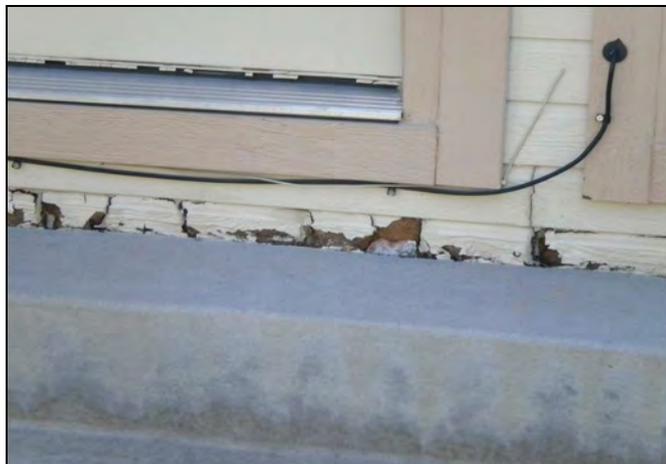
**Comp #: 811 Siding/Trim 1 - Replace 25%**

Evaluation: Siding ranges from good to poor condition with several areas showing signs of deterioration, particularly near patios and grade level areas. Recommend repairing siding that presents an immediate issue with water/moisture penetration. Based on current economic conditions, funding for replacement is based on installation of a Hardie Board siding which is currently at a similar price point to a Masonite product.

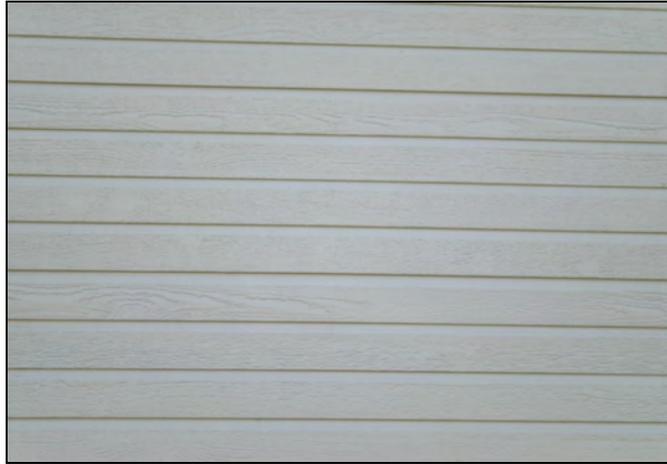
**Comp #:** 811 Siding/Trim 2 - Replace 25%

Evaluation: Siding ranges from good to poor condition with several areas showing signs of deterioration, particularly near patios and grade level areas. Recommend repairing siding that presents an immediate issue with water/moisture penetration. Based on current economic conditions, funding for replacement is based on installation of a Hardie Board siding which is currently at a similar price point to a Masonite product.

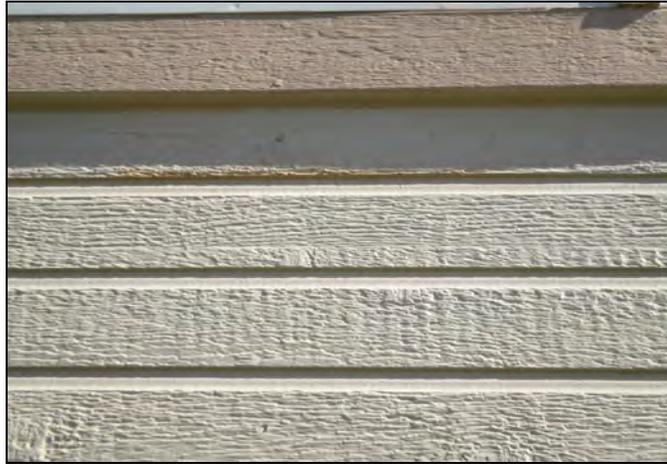
Comp #: 811 Siding/Trim 3 - Replace 25%

Evaluation: Siding ranges from good to poor condition with several areas showing signs of deterioration, particularly near patios and grade level areas. Recommend repairing siding that presents an immediate issue with water/moisture penetration. Based on current economic conditions, funding for replacement is based on installation of a Hardie Board siding which is currently at a similar price point to a Masonite product.

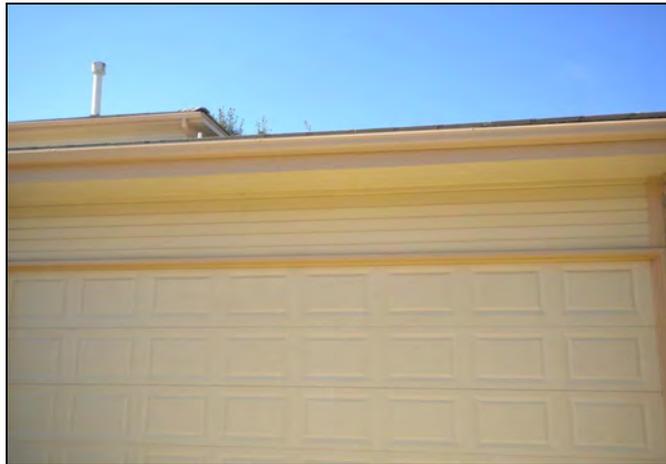
**Comp #:** 811 Siding/Trim 4 - Replace 25%

Evaluation: Siding ranges from good to poor condition with several areas showing signs of deterioration, particularly near patios and grade level areas. Recommend repairing siding that presents an immediate issue with water/moisture penetration. Based on current economic conditions, funding for replacement is based on installation of a Hardie Board siding which is currently at a similar price point to a Masonite product.

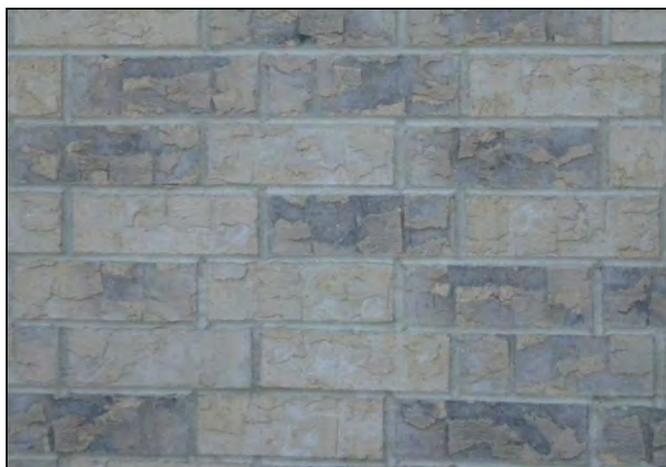
**Comp #:** 830 Brick Veneer - Repoint/Repair

Evaluation: Brick veneer is in overall good condition with no noted areas of missing brick. Recommend yearly inspections to ensure bricks are intact. Subsurface moisture when exposed to a freeze/thaw cycle will accelerate the useful life of this component. Recommend repairing damaged areas immediately.

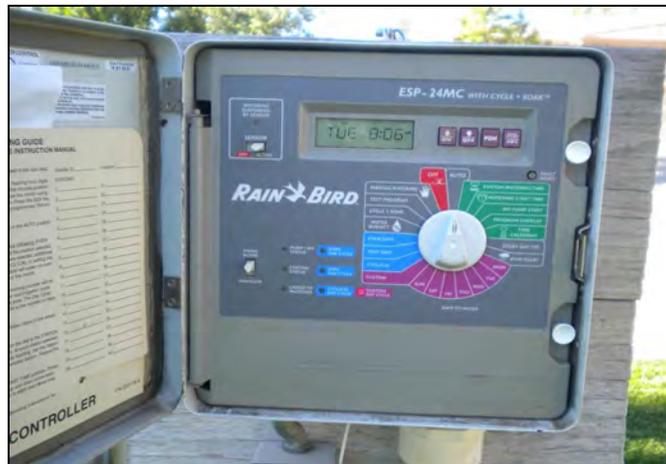
**Comp #: 1003 Irrigation System - Repair (part)**

Evaluation: Medium sized irrigation system consists of (2) Rainbird ESP controllers, (1) Febco backflow preventer and numerous LF of pipes and heads. Funding is to maintain system on a regular basis with no anticipation of removal and replacement of entire system at one time.

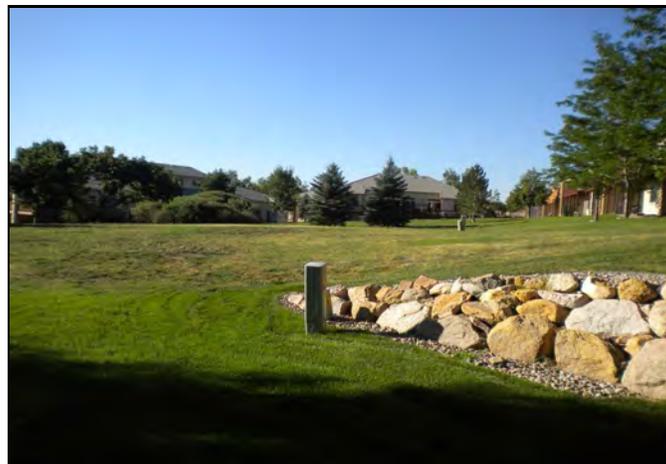
**Comp #: 1005 Landscaping - Replace (part)**

Evaluation: A major landscape renovation project has been proposed to reduce the amount of sod and irrigation in the central common area. Funding anticipates execution of the project, which will reduce overall annual maintenance costs for the Association.

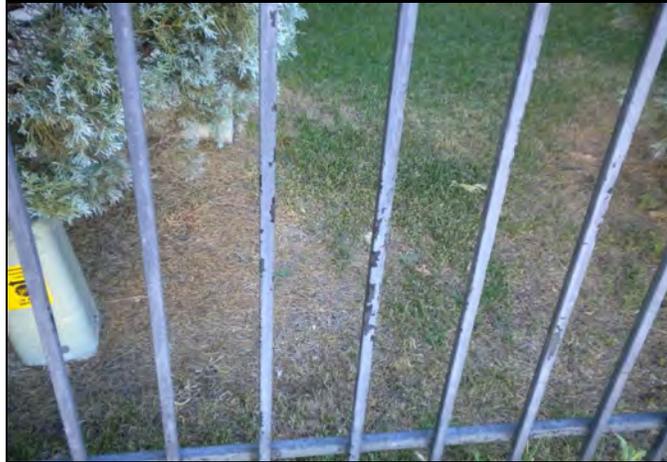
**Comp #: 1107 Metal Fence/Rail - Repaint**

Evaluation: Metal fence is in fair to poor condition with signs of fading and chipping paint/surface. Recommend repainting to maintain appearance and prevent rusting.

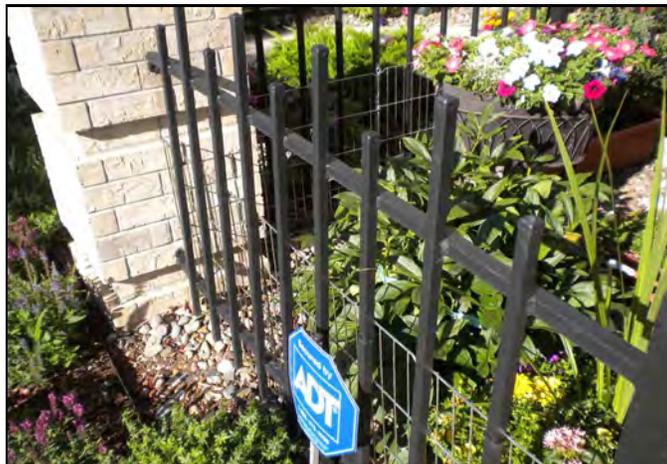
**Comp #: 1107 Unit Fence - Repaint (20%)**

Evaluation: Metal fence is in good to fair condition with minor signs of fading or chipping. Recommend repainting on a regular basis to maintain appearance and to protect the metal from the elements. Funding anticipates painting on a regular cycle so that all metal is painted every 5 years.

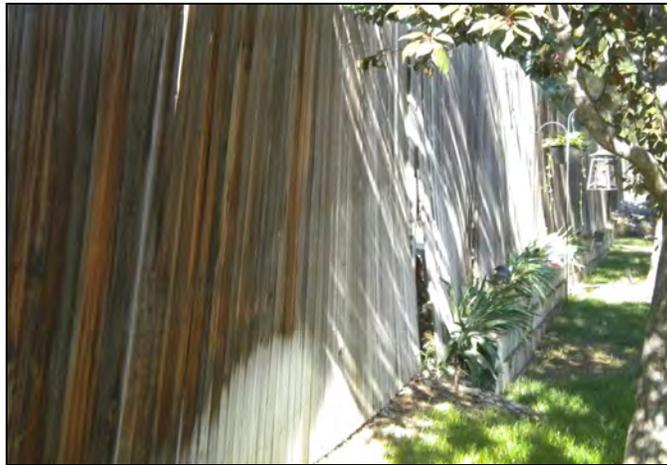
**Comp #: 1109 Wood Fence - Maintain**

Evaluation: Wood fence is not owned and maintained by the HOA. However, it may be in the best interest of the HOA to maintain one side of the fence to control appearance. This may mean sealing or staining and minor repairs, projects to be done from the ongoing operational maintenance budget.

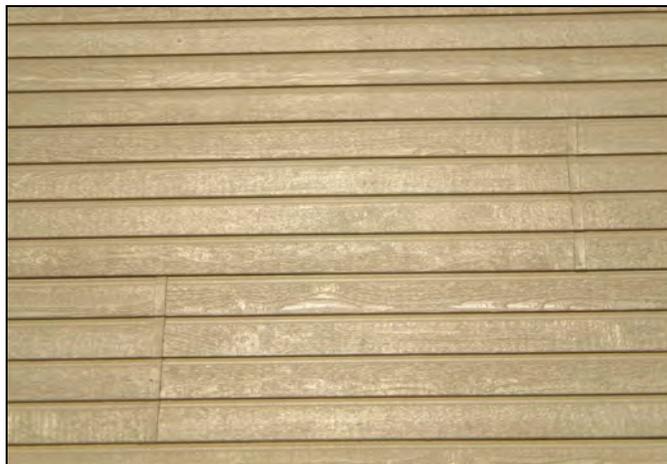
**Comp #: 1112 Siding - Repaint**

Evaluation: Siding ranges from good to fair condition with signs of fading and cracks at the joints. As reported by the property manager, units are moving to a 7 year paint cycle which will complete approximately 11 units per year.

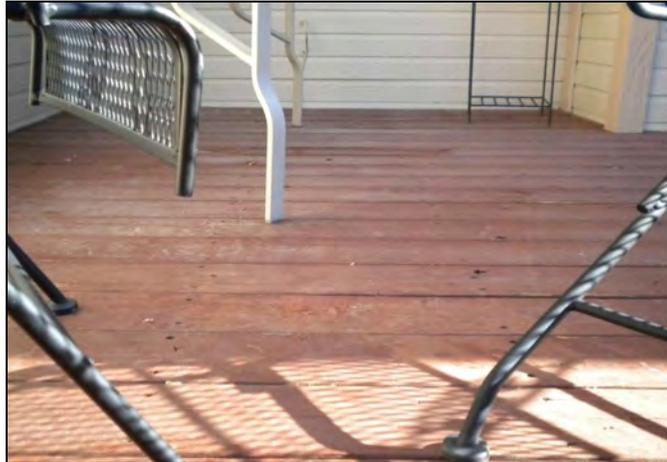
**Comp #:** 1116 **Wood Deck - Re-seal**

Evaluation: Decks range from good to fair condition with signs of raised grain which is a indication of dry wood. Maintain by staining/re-sealing with other exterior painting projects. Funding anticipates re-sealing approximately 6 decks per years so that all decks are sealed every 7 years. The number and cost will be reduced as decks are replaced with the composite materials as outlined in component #109.

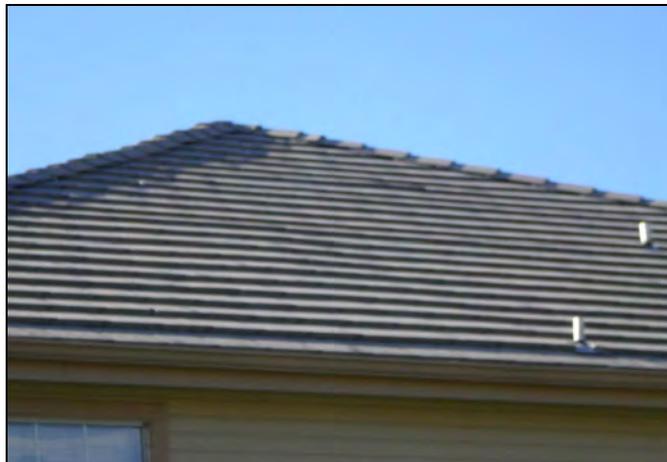
**Comp #:** 1304 **Tile Roof - Repair**

Evaluation: Tile roofs appear in good condition with no reported problems. It is reported that high winds are the cause of ongoing tile replacement. Funding is for replacing tile as needed.

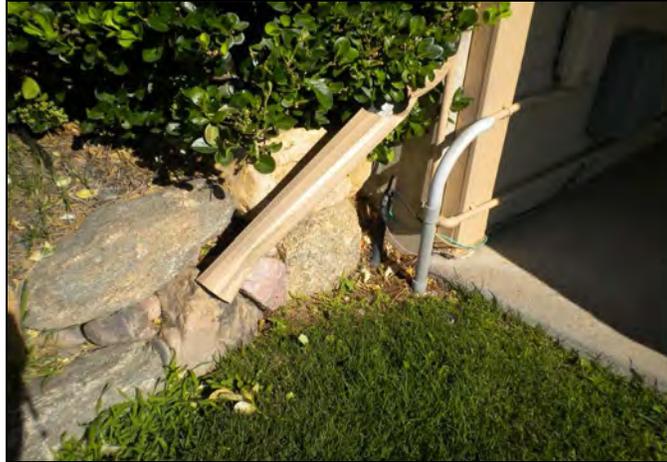
**Comp #:** 1310 Gutters/Downspouts - Replace (part)

Evaluation: Gutters appear in good condition with limited signs of damage. Maintain by cleaning, inspecting and painting on a regular cycle. Funding is for repairs and replacing sections as needed, with no anticipation of complete replacement at one time.

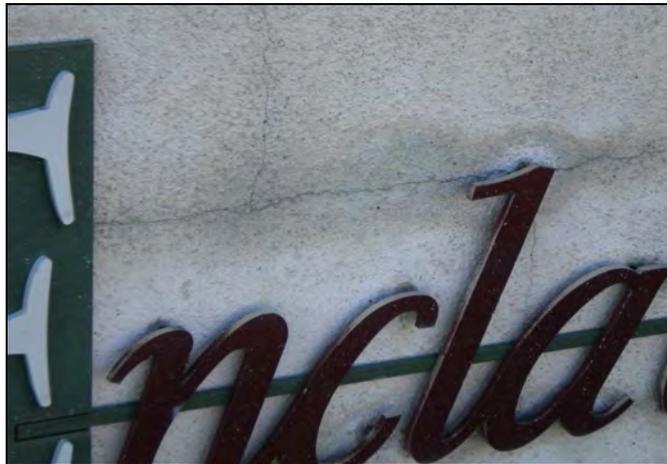
**Comp #:** 1402 Signage - Refurbish

Evaluation: Monument signs are in poor condition with signs of cracked stucco and concrete on the surface and missing finish on lettering. Funding is to refurbish monuments periodically to maintain the appearance of the community.
